Tuesday, January 29, 2013

## MINI Cooper S: Battery Box Water Leak - the presence of water in the back hatch storage compartment of several R50 and R53 MINI Coopers.

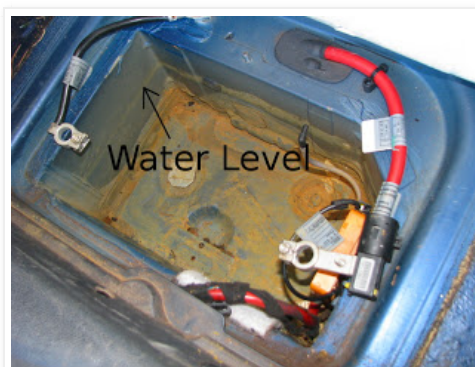
Battery Compartment half filled with water

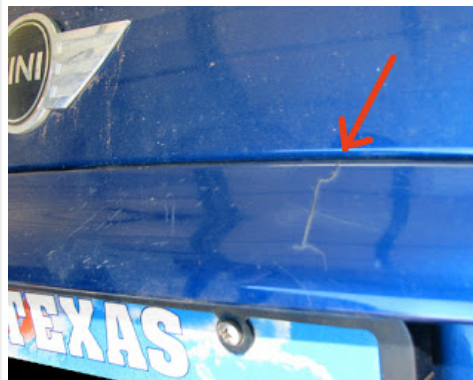
Even a small crack can cause the seal to fail and water to enter the hatch.

Something we have seen in our shop more and more frequently as these cars get older and take some abuse, is the presence of water in the back hatch storage compartment of several R50 and R53 MINI Coopers. This problem is directly attributed to the seal around the hatch door handle wearing out and allowing rain and other water in. Sometimes the leak can come from the plastic handle itself cracking from repeated pulling or from using it to support the weight of the hatch itself.

This handle is held on by 4 screws and is easy to replace on your own. If your handle is not cracked and in good shape, you can just replace the gasket. If the handle is cracked, you can replace the entire handle, with a new gasket included, safely and easily. If you ever wanted to upgrade the look of the rear of your MINI, this is also a great opportunity to upgrade to a black or chrome handle that will not require any color match painting.

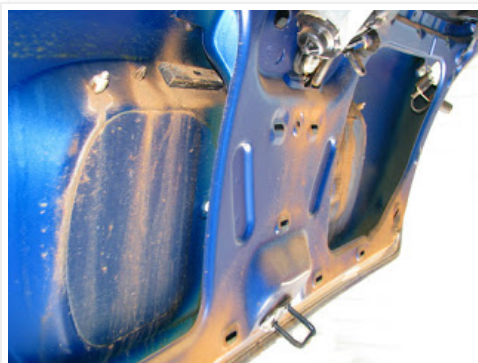
Rust and mud spreading from the screw holes

This can be a costly repair if left unchecked. Not only have we seen rust damage in these areas that can rot the sheet metal, but in the Cooper S the battery and several electronics attached to the battery can be destroyed. Repair of the cables, sensors, and fuses connected to the battery are a minimum of several hundred dollars in parts alone and will require several labor hours of wire routing.

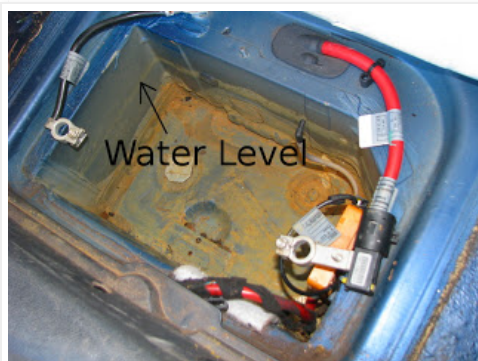
Battery Compartment half filled with water

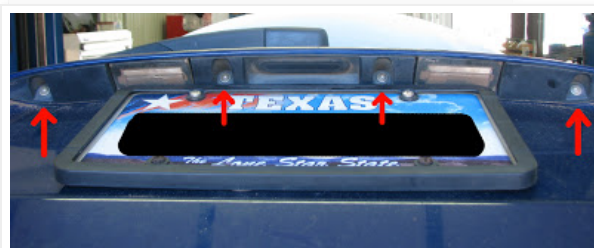
Installation and removal only involves these four screws
